STATE OF CALIFORNIA  
HIGHWAY TRANSPORTATION AGENCY  
DEPARTMENT OF PUBLIC WORKS  
DIVISION OF HIGHWAYS

A REPORT OF  
A SURVEY OF EARTH-BORNE TRUCK VIBRATIONS  
ADJACENT TO AND AROUND MASTERTON'S HOUSE

JULY 1966

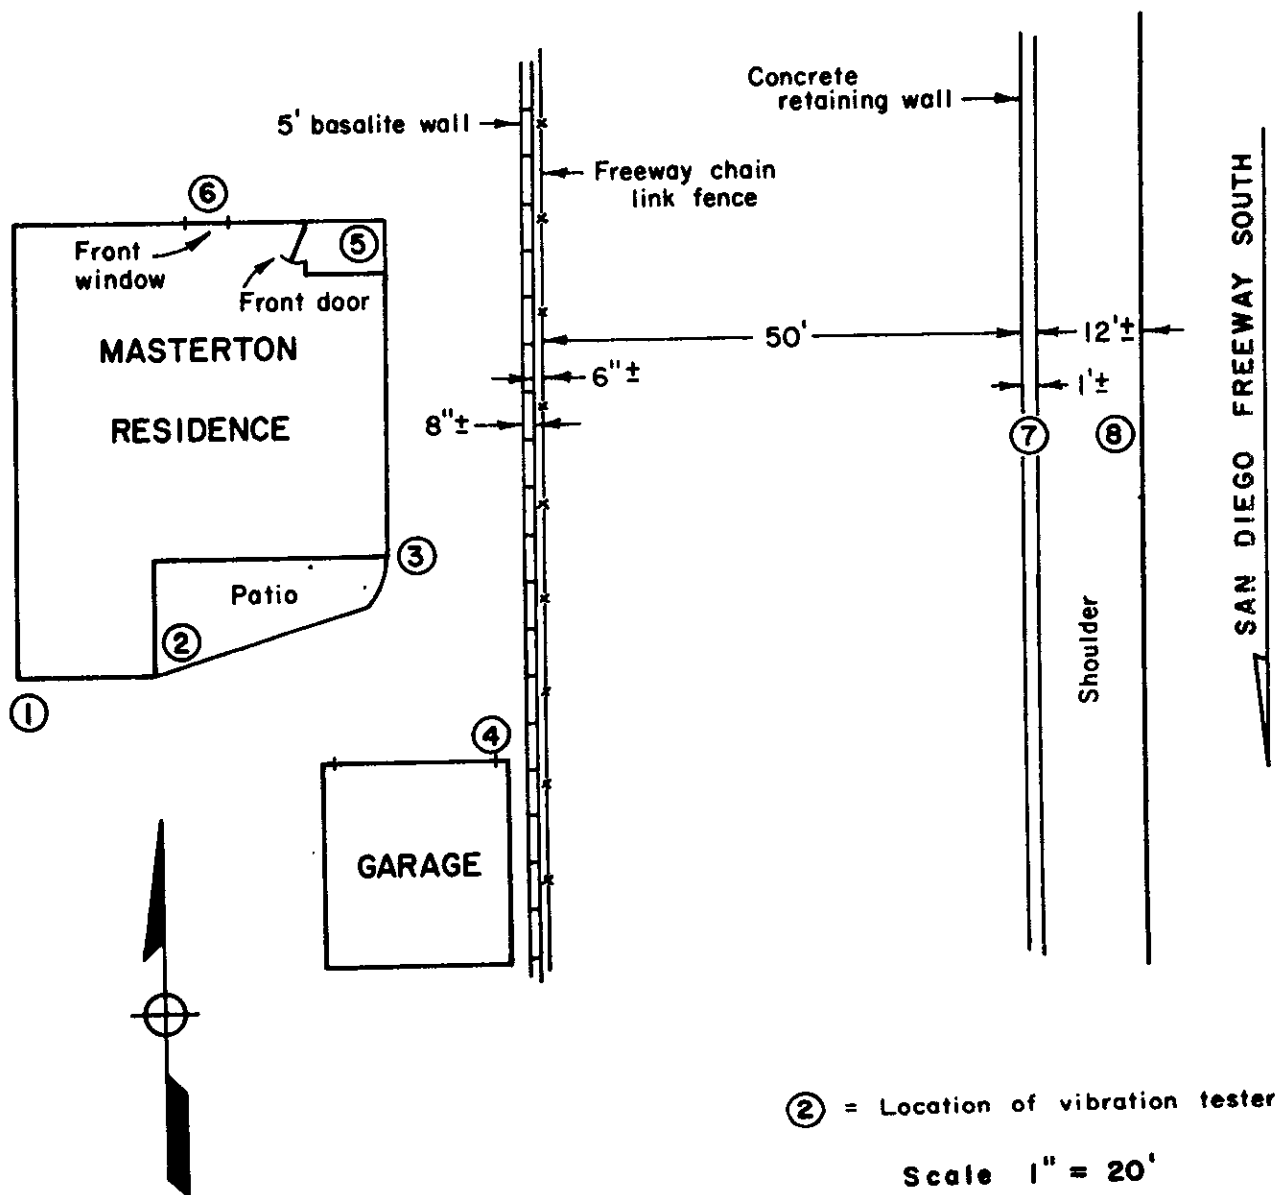
**— PLAN VIEW OF VIBRATION TESTER LOCATIONS —**

Each time that a large truck passed by Mrs. Masterton's property on the outside lane, the vibration tester recorder was turned on to record any vertical earth-borne vibrations emanating from the truck passage. Eight different locations, one at a time, were monitored this way. Locations monitored are shown on Exhibit 3, and Exhibits 4 and 5 are photographs of the 8 locations.

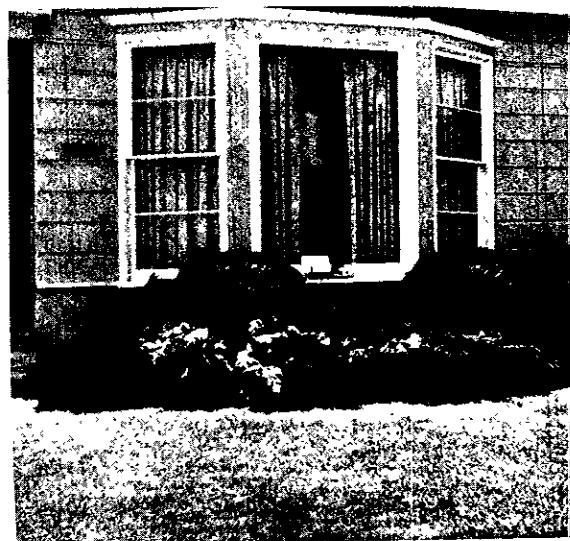
Location 6

Mrs. Masterton has stated that her chandelier lamp by her front window, Location 6, would "tinkle" due to passage of heavy trucks. The vibration tester was placed on this outside window sill and no recordable vibrations were picked up. It is well known that a passage of a heavy truck can cause glass window panes to rattle from air-borne sound and yet cause no house structural damage. Similarly, sonic booms and wind can shake and rattle a house and yet not structurally damage it.

For a comparison, the window sill was rapped lightly with a corner of a clipboard. Run #42 shows that the window sill vibrated at a peak to peak displacement of 0.00012" at a frequency of 50 cps. This is in the same order of magnitude as the average vibration level (0.00015" at 34 cps) alongside of the freeway. It is well known that the activities of the inhabitants of the house (opening and closing of doors, windows,

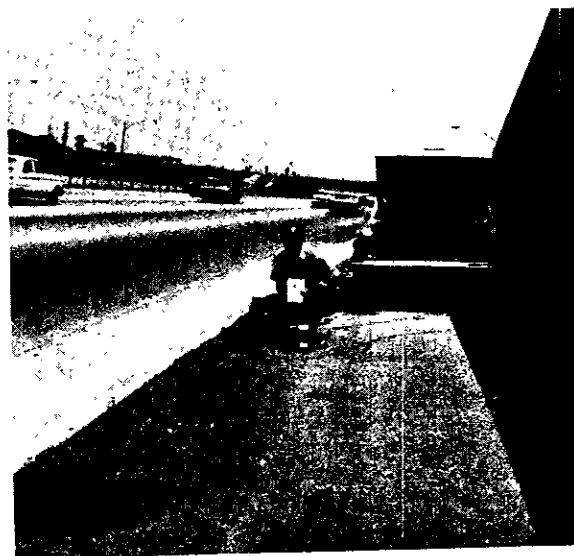
vibrations were measurable around Mrs. Masterton's house or on the retaining wall as shown on Runs 1 through 62. Vibrations were measurable at Location 8 alongside the traveled way. The largest vibration was in Run #69 with a movement of 0.00045" peak-to-peak at a frequency of 25 cps. The average for the 18 runs at Location 8 was 0.00015 inches peak-to-peak displacement and at an average frequency of 34 cps.

Note that the largest vibration measured was alongside the freeway edge, Location 8, Run #69, and it was 0.00045" at 25 cps. This maximum vibration value was just at the threshold of concern of Sutherland's study and would certainly be dissipated in the distance from the freeway edge to Mrs. Masterton's house.

Bureau of Mines Bulletin #442 indicates that the peak to peak displacement vibrations should be in excess of 0.10" before concern is necessary as to house damage. The largest vibration measured was 0.00045", alongside the freeway at Location 8, and was 222 times less than the Bureau of Mines

damage-caution criteria. This criteria would indicate that a house alongside the freeway, at Location 8, would not be subject to structural damages from freeway earth-borne vibrations.
